LABC Registered Construction Details Masonry

Registration Number: E11MCPF1

External Masonry Cavity Wall

Pitched Roof Eaves

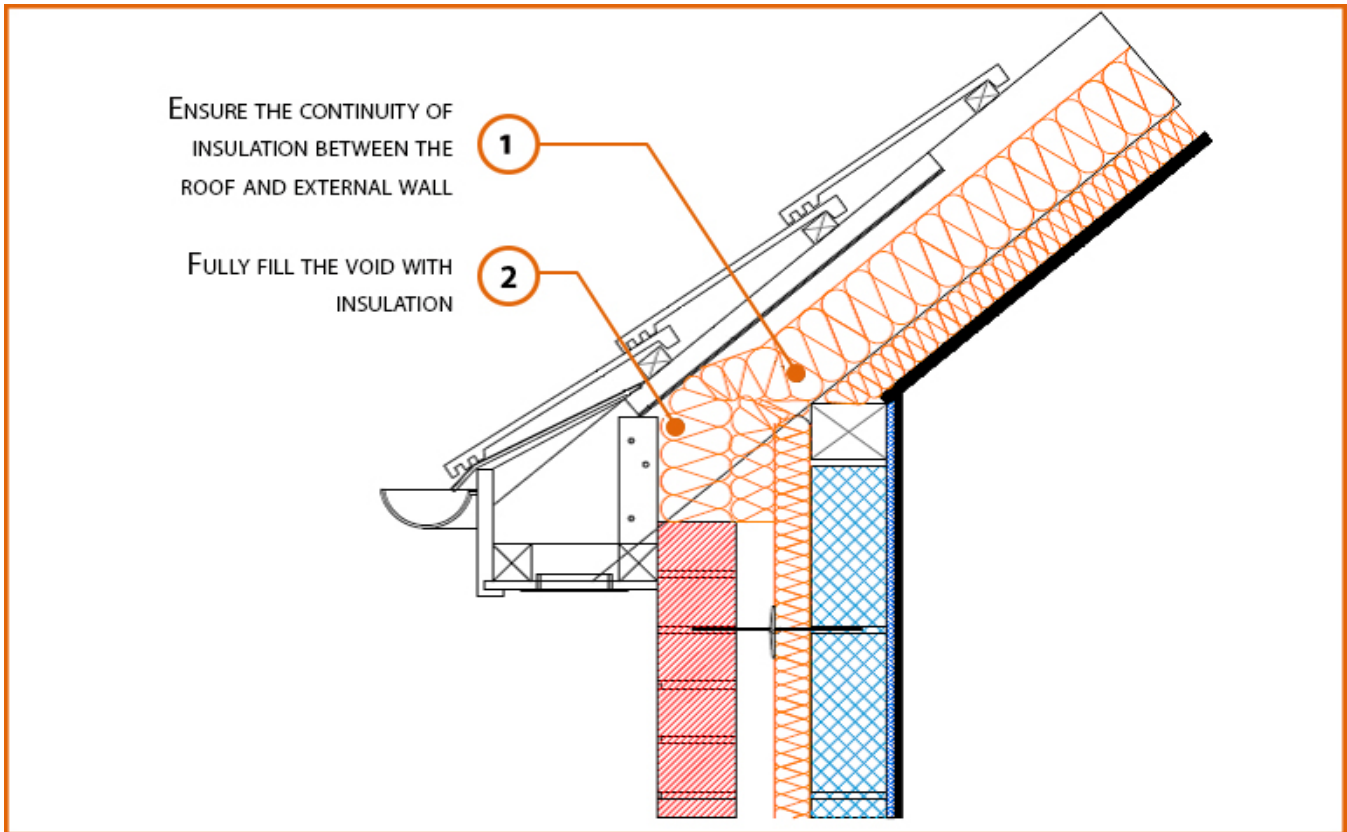
Build Up

Masonry Outer Leaf ($\lambda = 0.77$)

Ultra Lightweight Concrete Block $\lambda \leq 0.28$ W/mK

Partial Fill Insulation

150mm insulation (0.022W/mK) between rafters

50mm insulation (0.022W/mK) beneath rafters

Inner leaf blockwork
	Ultra Lightweight Concrete Block $\lambda \leq 0.28$ W/mK
Cavity Insulation	ψ -value W/mK
50mm $\lambda=0.022$	-0.008
100mm $\lambda=0.022$	-0.007

- Ensure cavities are kept clean of mortar snots and other debris during construction
- Ensure gap between wall plate and eaves ventilator is fully filled to maintain continuity of insulation through the junction. For partial fill, compressible insulation should be tucked into the head of the cavity.

- The eaves insulation should not compromise the cross flow ventilation or free water drainage below timber battens.
- Consider whether a vapour control plasterboard or separate vapour control barrier is required.

- Fire resistance will also be required for room in roof situations.
- Ensure eaves ventilation does not compromise free water drainage below the tiling battens.

- Fix ceiling plasterboard first and seal all gaps between ceiling and masonry then seal all penetrations through air barrier with flexible sealant.
- Read in conjunction with roof details E12 and E13.

- Cavity barriers may require an additional vertical DPC and/or cavity tray.
- Cavity must be closed at head of wall (insulation is often omitted here, or poorly fitted) Recommend calcium silicate or cement board closer so detail is not relying on compressed insulation

- Note that a cavity barrier should, wherever possible, be tightly fitted to a rigid construction and mechanically fixed in position. ADBV2 Para 9.14 identifies conditions where this may not be possible, for instance at a wall/roof junction with slates or tiles. In this case the junction should be fire-stopped.
